AD A 053899

4. TIT	LE (and Subtitle)			-	5. TYPE OF REPORT & PERIOD COVERE
	ponent Dan se (EMP) I			omagnetic 9	Technical Memorate
Pul	se (EMP) 1	induced Ti	ransien	ts.	6. PERFORMING ORG. REPORT NUMBER

7. AUT	HOR(e)				B. CONTRACT OR GRANT NUMBER(*)
Jos	eph R./Mil	letta			DA. 1W062118AD51
	FORMING ORGANI				10. PROGRAM ELEMENT, PROJECT, TASK AREA & WORK UNIT NUMBERS
	ry Diamond O Powder M		ories	•	Program Ele: 62118A
	lphi, MD				
	TROLLING OFFI			. (1	12. REPORT DATE
	Army Mater adiness Co		copment	and L	October 1977
21	xandria, V				13. NUMBER OF PAGES
			ESS(II dillere	nt from Controlling Office	SECURITY CLASS. (of this report)
					UNCLASSIFIED
					15a. DECLASSIFICATION/DOWNGRADING

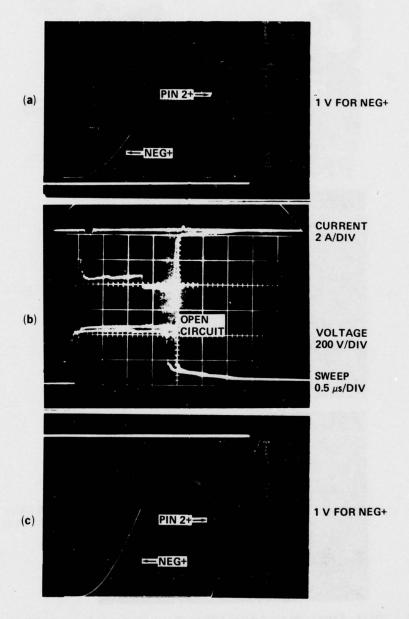
Figure 16. Test data, Burr-Brown 1752/17 operational amplifier, unbiased, degradation, pulse 42; results of 460-V test across pin 2 (input 2) and negative terminal (pin 2+): (a) before-pulse-test data; (b) pulse data showing initiation of apparent multiple second breakdowns in both voltage and current sweeps; (c) after-pulse-test electrical measurements showing slightly more conductive characteristic for "neg+." Output of voltage follower was 5.8 V before test and 5.3 V after test. Impedance of 160 ohms can be calculated from data in (b) before apparent first "second breakdown" in 330-V pulse test.

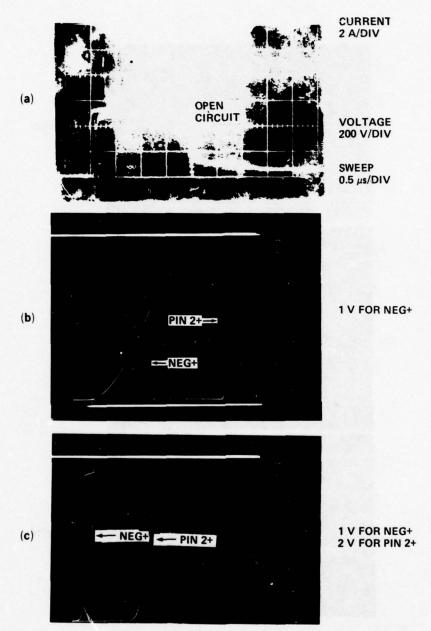
Figure 17. Test data, Burr-Brown 1752/.7 operational amplifier, unbiased, destruction, pulse 43; results of 550-V test across pin 2 (input 2) and negative terminal (pin 2+): (a) pulse data: (b) before-pulse-test electrical measurements; (c) after-pulse-test electrical measurements. Output of voltage follower was 5.3 V before test and -1.8 V after test.

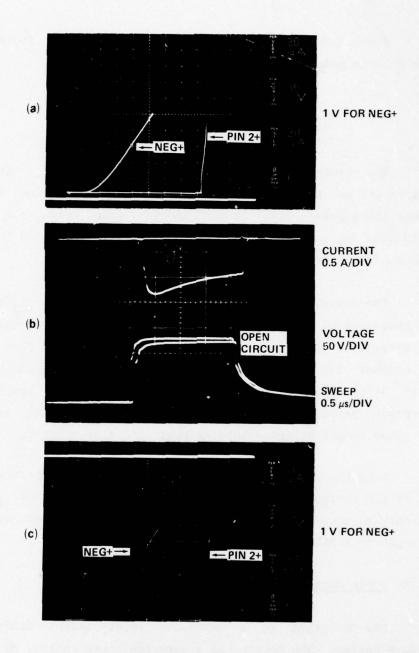
Figure 18. Test data, Burr-Brown 1752/17 operational amplifier, biased, undamaged, pulse 5; results of 160-V test on device 2 across pin 2 (input 2) and ground in active circuit: (a) before-pulse-test electrical measurements; (b) pulse data; (c) after-pulse-test electrical measurements. Active input impedance of 55 ohms can be calculated from (b). Output of voltage follower was 5.7 V before and after test.

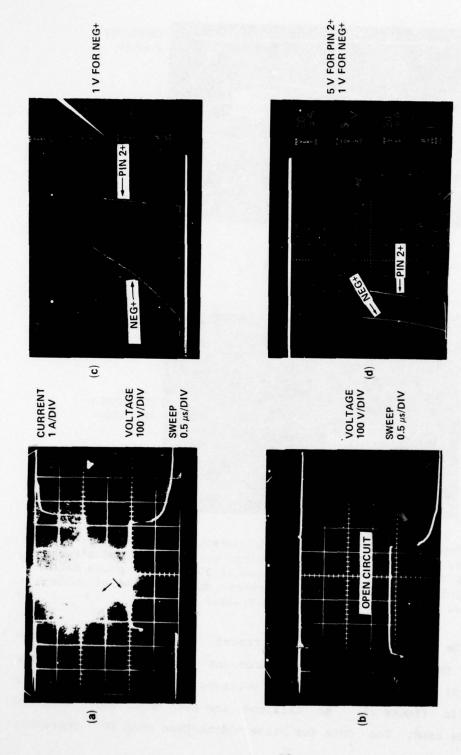
(a) and (b) pulse data; (c) before-pulse-test data; (d) after-pulse-test data. Possible second breakdown within module is indicated in (a) (arrows). Impedance of 83 ohms can be calculated pulse 8; results of 230-V test on device 2 across pin 2 (input 2) and ground in active circuit; from (a) before indication of breakdown. Output of voltage follower was 5.7 V before test and Figure 19. Test data, Burr-Brown 1752/17 operational amplifier, biased, severe degradation, 5.3 V after test.

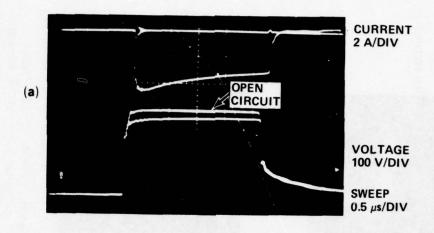
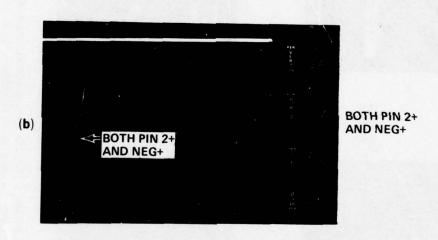
Figure 20. Test data, Burr-Brown 1752/17 operational amplifier, biased, destruction, pulse 10; device 2 was pulsed across pin 2 and circuit ground (pin 2+), with 2-μs voltage pulse of 300 V: (a) pulse data; (b) after-pulse-test electrical measurement data. Output of voltage follower was 5.2 V before test and 13 V after test.

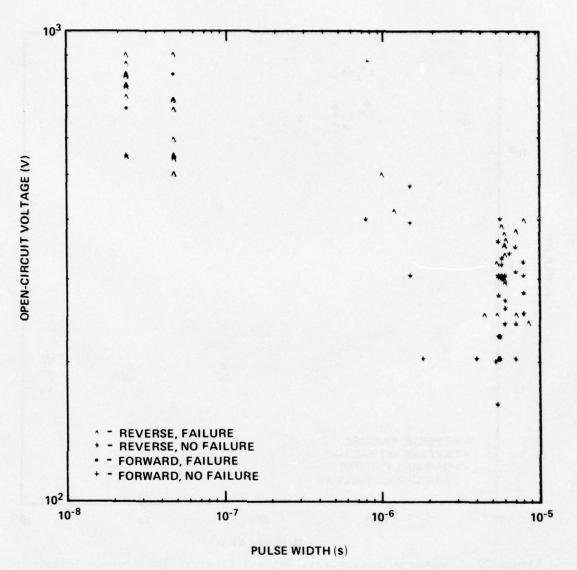
Figure 21. Damage points, voltage, General Electric 1N69A diode.

The voltage and current traces taken during the step stressing of the diode indicated a predominant voltage threshold failure mode (fig. 9). The open-circuit voltages applied to the diode are graphed in figure 21. No failures are seen under 200 V with the 50-ohm source used. The data for pulse widths less than 10^{-7} represent

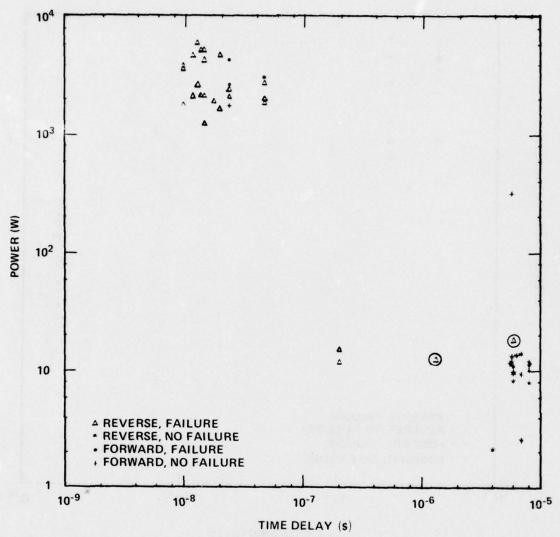
The power dissipation points are plotted in figure 22. Two diodes did exhibit what could be termed a thermal second-breakdown failure mode. (These two points are circled in fig. 22). The time

Figure 22. Damage points, power, General Electric 1N69A diode (circled symbols represent devices that exhibited thermal second breakdown).

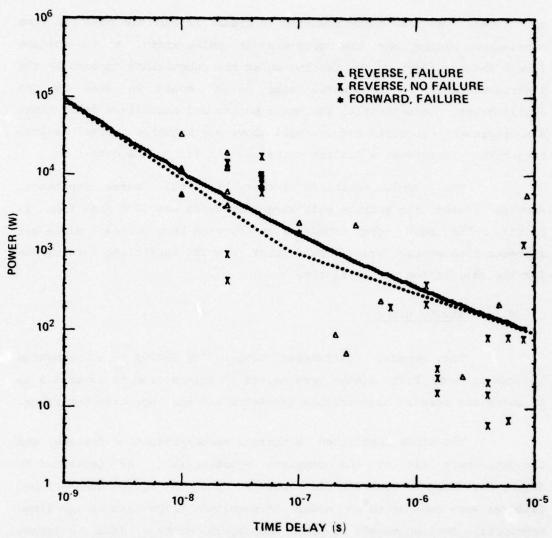
Figure 23. Damage curve, power, General Instruments 1N270A diode.

The diode exhibited a thermal second-breakdown failure, and the data were fit to the complete equation (9). As indicated in figure 23, there is considerable scatter about the fitted damage line. Failures were seen up to an order of magnitude below this damage line. Appropriate caution should be taken when applying these data. A larger safety margin than the nominal 1/10 line often used would be justifiable for analyses on circuits containing this diode. The forward failure points lie on or above this established line. The mean bulk surge impedance in the reverse direction is 3400 ohms for 18 long pulses (range: 75 to 9750 ohms) and 22.5 ohms for 19 short pulses (range: 2.5 to 95 ohms). The mean bulk surge impedance forward biased (15.8 ohms) was determined from only five measurements.*

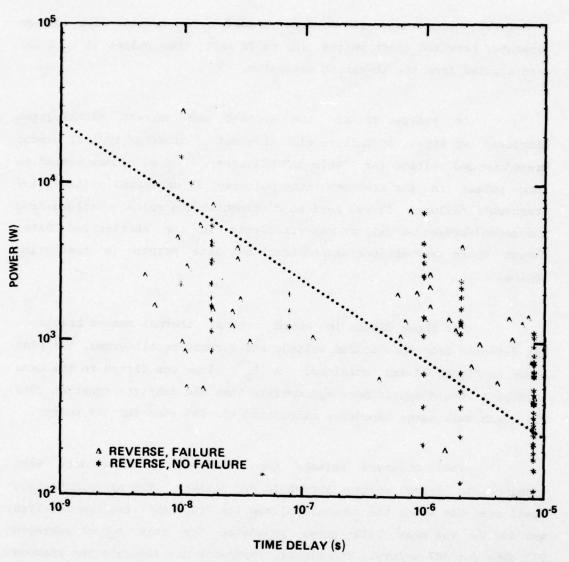
Figure 24. Damage line, power, Texas Instruments 1N457 diode (observed thermal second-breakdown points only).

The observed voltage (or "turn-on") failure data were examined to detect voltage threshold for failure. The minimum voltage level seen for which the typical voltage (or "turn-on") failure resulted was 500 V. The mean bulk surge impedance for this subset averaged 913 ohms for 107 points. The higher impedance may indicate the reasons for this voltage threshold failure mode.

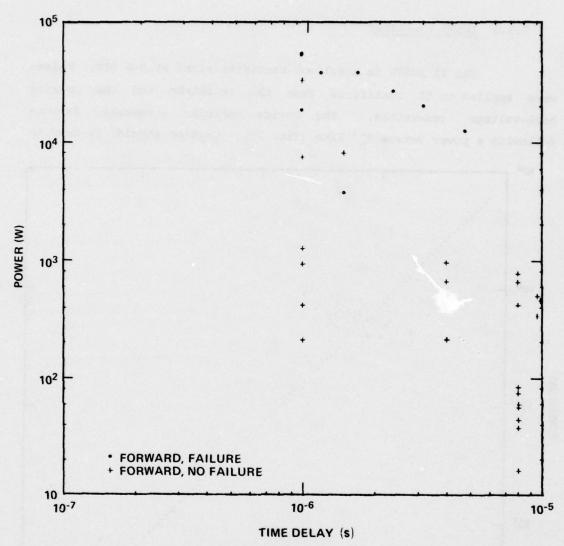
Figure 25. Damage points, power, Texas Instruments 1N457 diode (forward-biased points).

Ten diodes were pulsed forward biased. Figure 25 plots the power versus failure time for these samples. The mean bulk surge impedance of 32 points pulsed from 1 to 8 μs was 0.406 ohms.

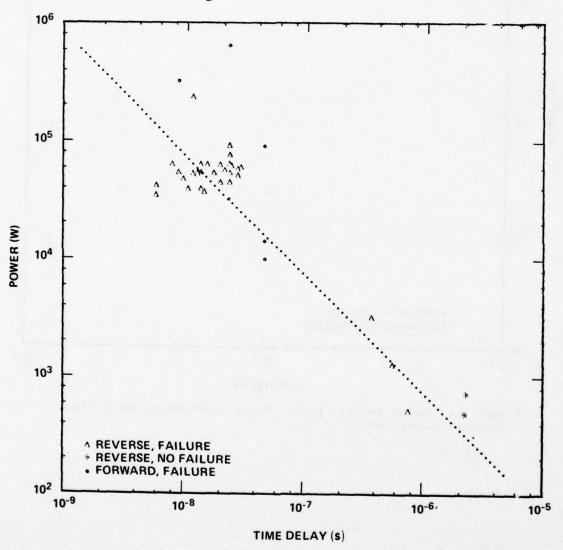
Figure 26. Damage line, power, Texas Instruments 1N539 rectifier.

The TI 1N539 is a silicon rectifier rated at 300 PIV. Pulses were applied on 50 rectifiers from the thyratron and the coaxial high-voltage generators. The device exhibits a thermal failure following a power versus $T_{\rm D}^{-1}$ line (fig. 26). Caution should be used in

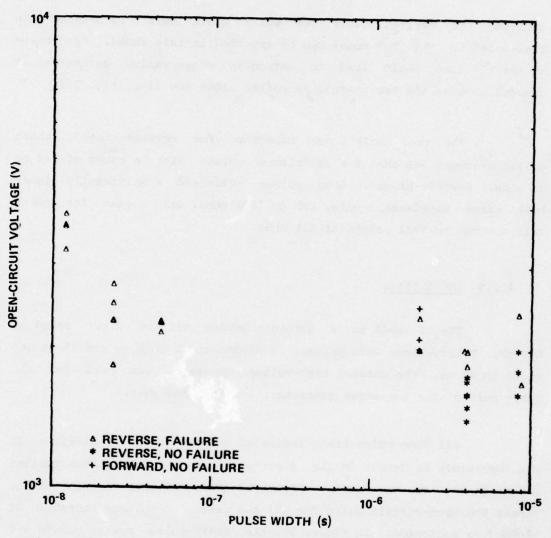
Figure 27. Damage points, voltage, Texas Instruments 1N645 diode.

All long-pulse tests indicated voltage threshold failure. It was impossible to detect in the short-pulse tests, though the failure mechanism may be the same. Figure 27 shows the open-circuit voltage versus the open-circuit pulse for all the tests. A voltage threshold of $\sim 1600 \text{ V}$ is indicated. In figure 28, the short-pulse power points are shown versus the delay time. A $T_D^{-\frac{1}{2}}$ line is fit to the data.

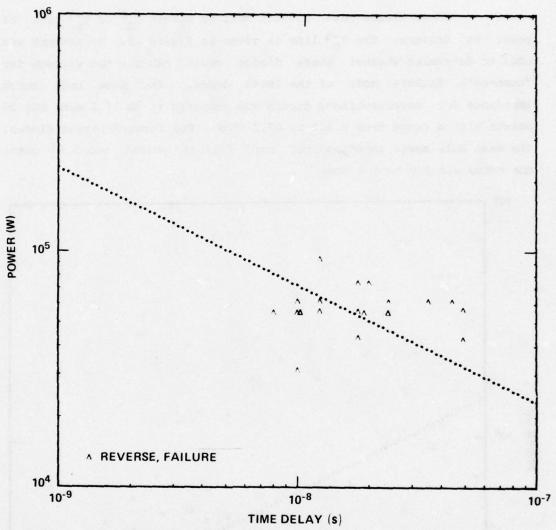
Figure 28. Damage line, power, Texas Instruments 1N645 diode, short-pulse points only.

The mean bulk surge impedances of reverse-biased diodes were 8.7 ohms for 21 diodes which failed at high-power short pulses and 1113 ohms for 12 no-fail diodes at long pulses. The bulk surge impedance tended to decrease under repeated pulsing at increasing power on the long pulse tests from an average of 1430 ohms for the initial pulse to 800 ohms just before failure.

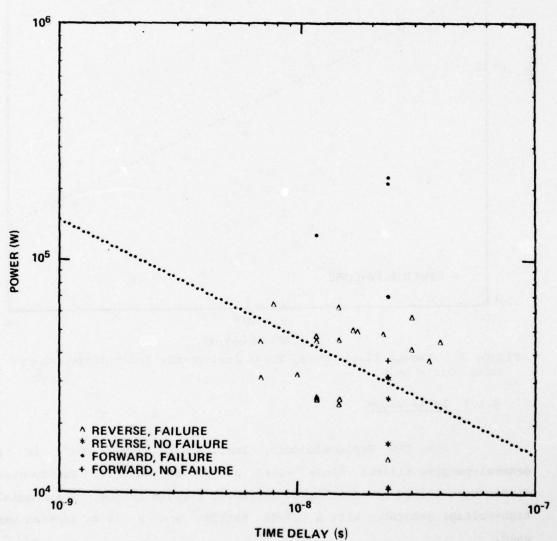
Figure 29. Damage line, power, TRW Semiconductors 1N647 diode.

These diodes did not fit well to either T_D^{-1} or $T_D^{-\frac{1}{2}}$ line of power to failure. The $T_D^{-\frac{1}{2}}$ line is given in figure 29. No attempt was made to determine whether these diodes would exhibit the voltage (or "turn-on") failure mode of the lN645 diode. The mean bulk surge impedance for reverse-biased diodes was computed to be 17.2 ohms for 26 points with a range from 0.533 to 67.2 ohms. For forward-biased diodes, the mean bulk surge impedance for eight failure points was 5.17 ohms; the range was 2.8 to 8.8 ohms.

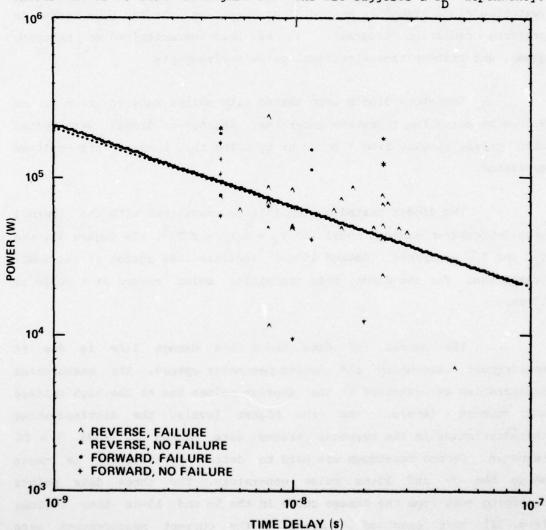
Figure 30. Damage curve, power, ITT Semiconductors 1N816 diode.

Reverse-biased failure points were fitted to the equation (9) failure model as shown in figure 30. The fit suggests a $T_D^{-\frac{1}{2}}$ dependency.

The mean bulk surge impedances for 27 diodes that failed and 11 that did not fail reverse biased averaged 20 ohms. The forward-biased bulk surge impedance for five tests including one no-failure diode averaged 10.2 ohms.

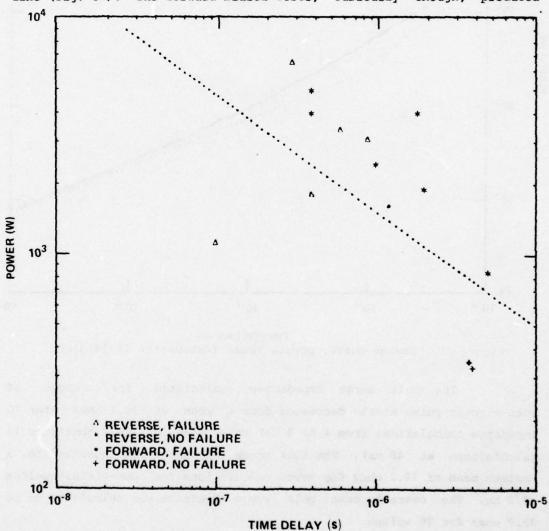
Figure 32. Damage line, power, TRW Semiconductors 1N956B capacitor.

The test oscillograms indicate a thermal second-breakdown failure mechanism. The reverse-biased damage data were fit to the $T_D^{-\frac{1}{2}}$ model. There is considerable spread about the nominal line (fig. 32). The forward-biased tests, curiously enough, produced

voltage and current oscillograms similar to those of the reverse-biased tests. A phenomenon like second breakdown was apparent in the data.

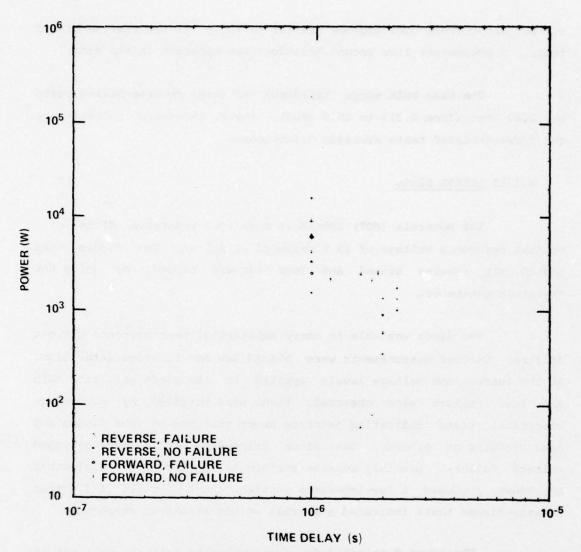
Figure 33. Damage points, power, Motorola 1N965B diode.

The power dissipated for reverse-biased failure was not fit to the T_D^{-1} thermal model because the spread about a line (fig. 33) would have been extreme due in part to the uncertainty in the exact current level and the combination of mechanisms to produce failure. The tests indicated that failure occurred at open-circuit voltages of ~1000 V. The source impedance, which includes an external 50-ohm series resistor, was approximately 100 ohms. The diode could not be damaged by forward-biased pulses. The device impedance averaged 0.154 ohms for 13 reverse-biased tests and 6.778 ohms for 8 forward-biased tests.

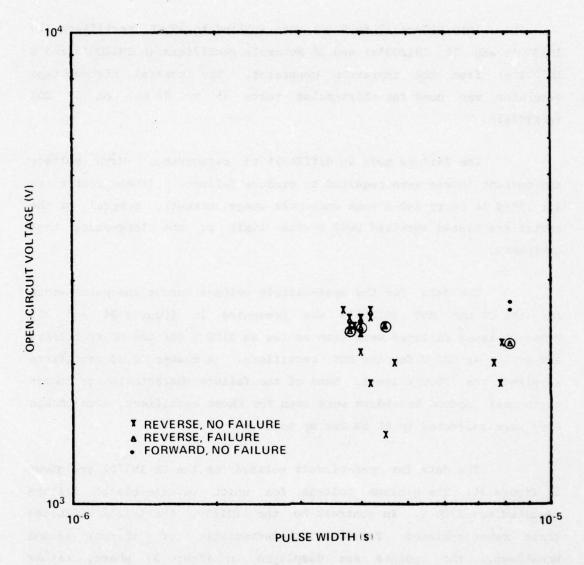
Figure 34. Damage points, voltage, General Electric 1N1200 rectifier (reverse failure data are circled).

The data for the open-circuit voltage versus the pulse width for the GE and MOT lNl200's are presented in figures 34 and 35. Reverse-biased failures were seen as low as 2100 V for the GE rectifiers and as low as 620 V for the MOT rectifiers. A number of GE rectifiers survived the 2600-V level. None of the failure characteristics common to thermal second breakdown were seen for these rectifiers, even though they were subjected to 60 kW for up to 4 μs .

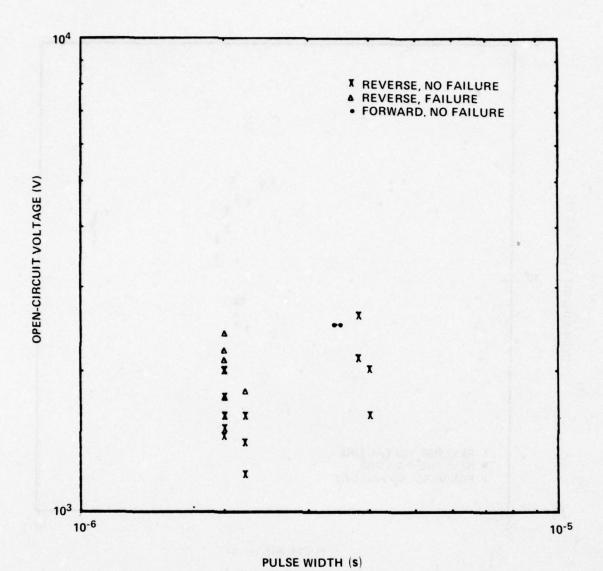
Figure 36. Damage points, voltage, General Electric 1N1202 rectifier.

The data for open-circuit voltage for the GE 1N1202 are given in figure 36. The minimum voltage for which reverse-biased failure resulted was 1700 V. In contrast to the 1N1200, the 1N1202 exhibited three reverse-biased failures characteristic of thermal second breakdown. The points are displayed in figure 37 where, rather optimistically, a $T_D^{-\frac{1}{2}}$ fit is shown. Analysis of this rectifier should consider both possible mechanisms for failure. Correspondingly, the data for the MOT 1N1202 are presented in figures 38 and 39. The minimum voltage for which failure resulted was 700 V.

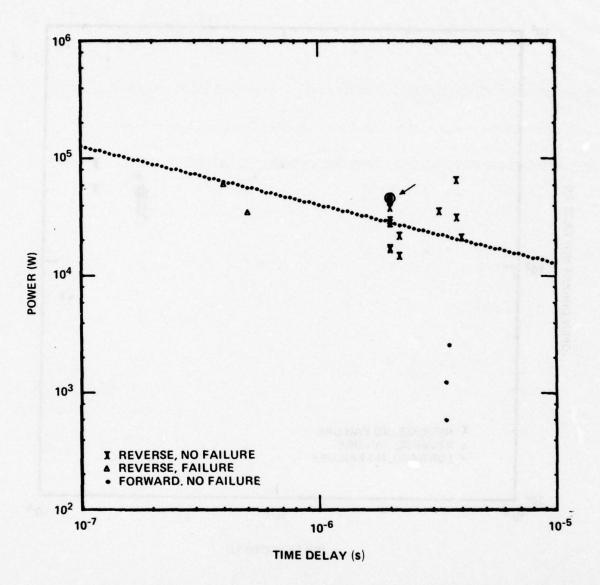
Figure 37. Damage line, power, General Electric 1N1202 rectifier (embedded reverse failure point at 2 µs is identified by arrow).

reverse-biased failures resulted in junction short circuits. In many of the reverse-biased failure tests, a series 47-ohm resistor was used to limit the pre- and postsecond-breakdown or voltage-breakdown current

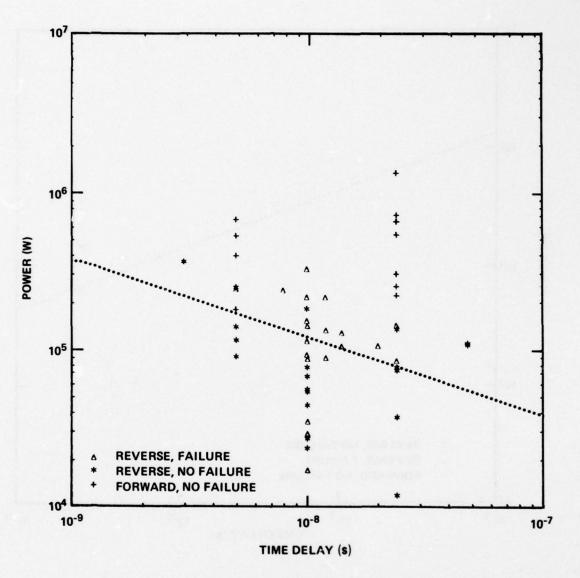
Figure 40. Damage line, power, Bendix lN1202A rectifier.

Figure 40 presents the data for the power versus the delay time for the short-pulse tests conducted on the BDX 1N1202A. The

failure characteristics were typical of second breakdown. But from the apparent failure mechanisms of the 1N1200 and 1N1202, the delay time may in fact be related to a statistical delay time for arc initiation,

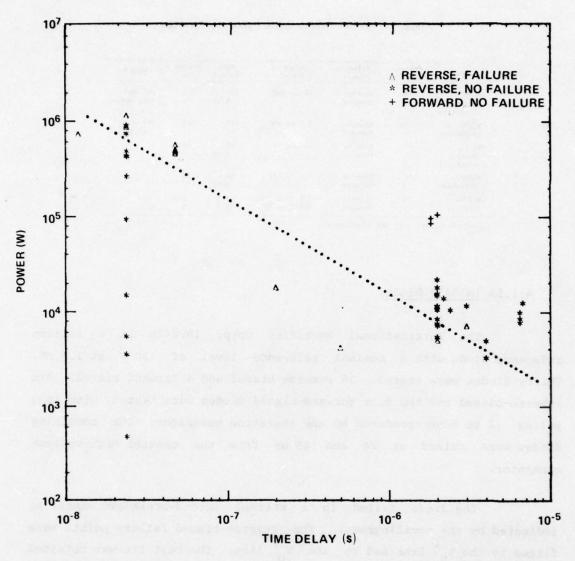
Figure 41. Damage line, power, International Rectifier 1N3047B diode.

The diode failed in a thermal second-breakdown manner as indicated by the oscillograms. The reverse-biased failure points were fitted to the $T_D^{-\frac{1}{2}}$ line and to the T_D^{-1} line; the best fit was obtained from the T_D^{-1} line (fig. 41).

The bulk surge impedance of the diode decreased as pulse width increased: 28 points at the 24- and 48-ns pulses averaged 7.06 ohms from a range of 3.64 to 17.1 ohms; 23 points at times greater than 1.0 µs averaged 1.17 ohms from a range of 0.36 to 3.0 ohms. The forward-biased bulk surge impedance averaged 4.17 ohms (for three points at 2 µs).

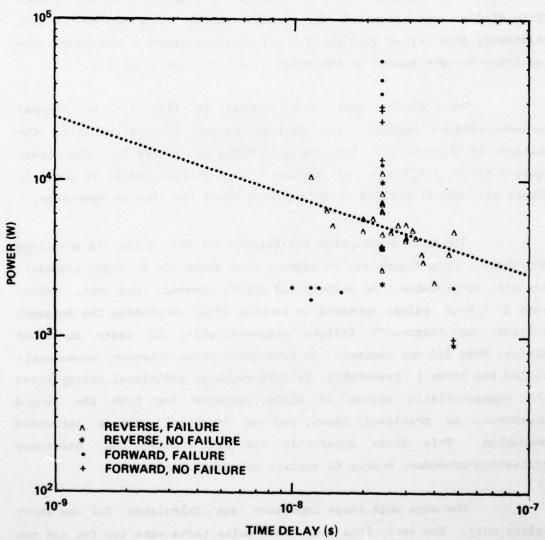
Figure 42. Damage line, power, Raytheon 1N3064 diode.

The failure mode for all diodes appears to follow the thermal model. Figure 42 shows the $T_D^{-\frac{1}{2}}$ line fitted to the reverse-biased failure points. The slope of -1/2 appears to fit the data better than a slope of -1; but, with the limited range in the data, the choice is arbitrary. The bulk surge impedance decreased at longer pulses: from a mean of 6.46 ohms for 19 reverse-biased points at 24 ns to 3.61 ohms for 15 reverse-biased points at 48 ns. Overall, the bulk surge impedance

ranged from 1.24 to 11.03 ohms with a mean of 5.2 ohms. In the forward-biased direction, nine sample points from the 24-ns tests yielded a mean of 4.93 ohms bulk surge impedance.

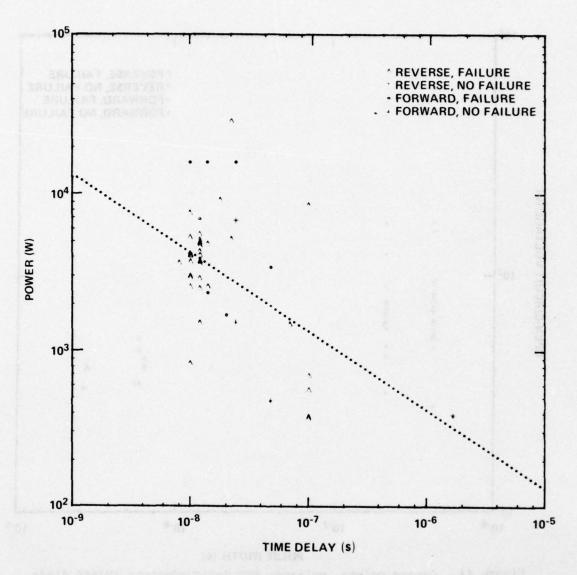
Figure 43. Damage line, power, ITT Semiconductors 1N3666 diode.

The diode does not appear to fail in the thermal second-breakdown manner. The failure voltage current exhibits the voltage (or "turn-on") failure characteristic of figure 9. The least squares fit to a $T_D^{-\frac{1}{2}}$ line of reverse-biased failure points is shown in figure 43. The dispersion of data points about the line is excessive.

disparate to provide any useful information. Computed impedance; from combined 24- and 48-ns pulses ranged from 2.0 to 17.0 ohms with a mean of 7.11 ohms for reverse-biased tests and from 1.40 to 6.23 ohms with a mean of 1.84 ohms for forward-biased tests.

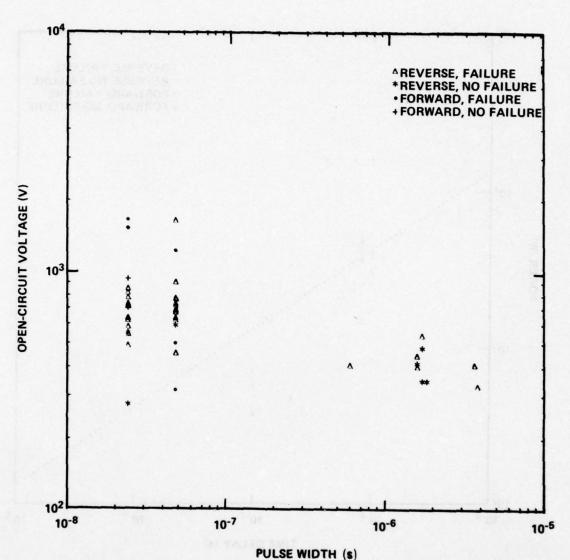
Figure 44. Damage points, voltage, ITT Semiconductors 1N3666 diode.

The best description for failure for the diode is a voltage threshold. From figure 44, it appears that above 300 V (open circuit), failure is probable. An anomaly did occur, however. One unit, pulsed with a 1.6-µs pulse, appeared to recover after exhibiting the apparent voltage (or "turn-on") failure characteristic. In tests on other diodes, they did not recover. (A subsequent pulse, however, permanently failed the diode.) Presumably, failure requires additional energy after the characteristic change in diode response for both the second breakdown, as previously known, and the "turn-on" voltage threshold mechanism. This diode apparently did not receive the necessary postsecond-breakdown energy to sustain permanent failure.

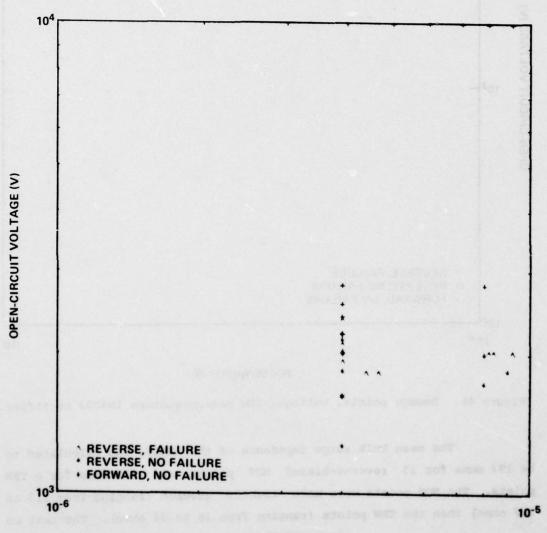
Figure 45. Damage points, voltage, Motorola 1N4003 rectifier.

Voltage (or "turn-on") failure was evident in each rectifier set tested. The MOT rectifier failure was predominantly of this type. The TRW rectifier also exhibited what appeared to be a thermal second-breakdown mechanism. Figures 45 to 47 plot the open-circuit pulse width versus the time delay for the rectifiers. The data for the power versus the delay time for the TRW rectifier are plotted in figure 48.

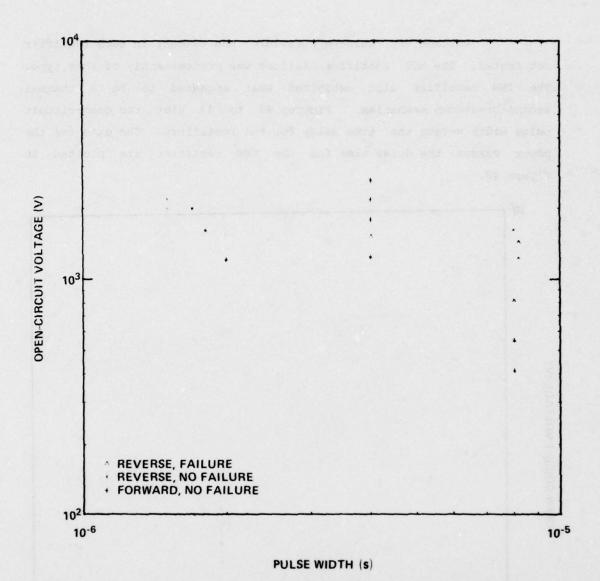
Figure 46. Damage points, voltage, TRW Semiconductors 1N4003 rectifier.

The mean bulk surge impedance of the 1N4003 was calculated to be 197 ohms for 13 reverse-biased MOT points and 129 ohms for 8 TRW points. The MOT points were more tightly grouped (ranging from 115 to 287 ohms) than the TRW points (ranging from 16 to 24 ohms). The test on

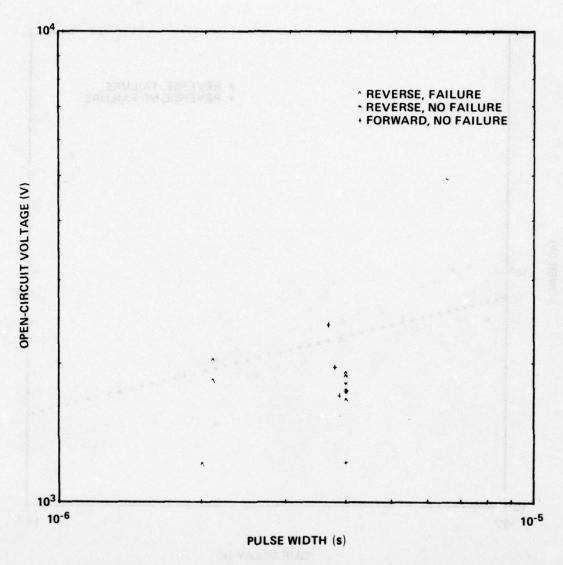
Figure 47. Damage points, voltage, Motorola 1N4005 rectifier.

the 1N4005 gave a reverse-biased mean bulk surge impedance for five points of 116 ohms. None of the 1N4000 series rectifiers could be damaged by forward-biased pulses with the instrumentation.

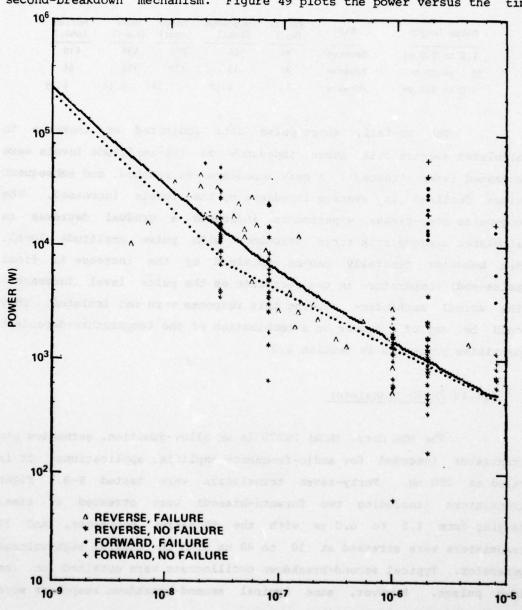
TIME DELAY (s)
Figure 49. Damage curve, power, Unitrode UT254 diode.

The rectifiers appeared to fail from the thermal second-breakdown mechanism. Figure 49 plots the power versus the time

to failure. The data are fit to the complete model. The breakpoint between the T_D^{-1} and $T_D^{-\frac{1}{2}}$ lines occurs at approximately 7000 W at 30 ns.

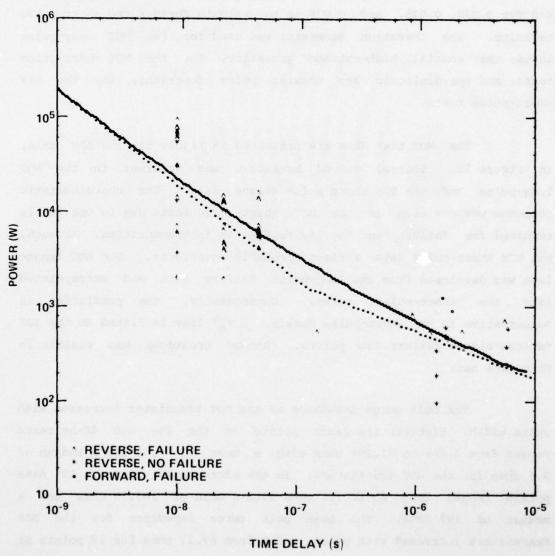
Figure 50. Damage curve, power, E-B, RCA 2N270 transistor.

The power versus the time to failure is shown in figure 50. The intersection of the T_D^{-1} and $T_D^{-\frac{1}{2}}$ asymptotes is approximately 1.5 kW at 120 ns. The mean bulk surge impedance for the reverse-biased E-B junction was calculated to be 18.1 ohms for short pulses and 107 ohms for long pulses.

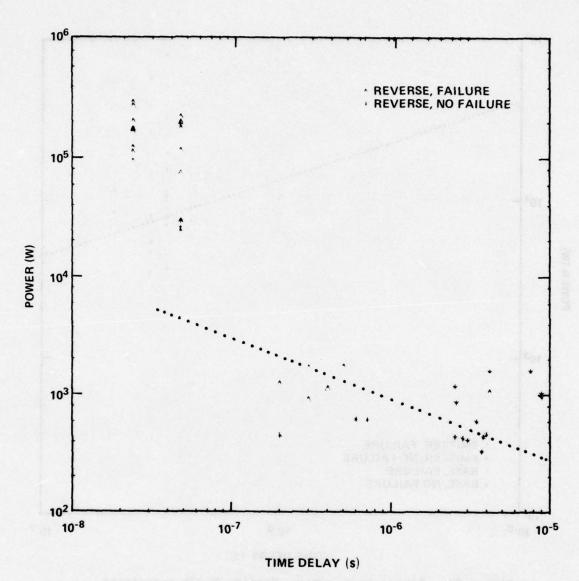
Figure 51. Damage line, power, E-B, Motorola 2N297A transistor.

The MOT test data are presented in figure 51; the BDX data, in figure 52. Thermal second breakdown was apparent in the MOT long-pulse and the BDX short-pulse damage data. The characteristic response was not seen in the MOT short-pulse tests due to the levels required for failure and the limitations in instrumentation. As such, the MOT short-pulse data reflect probable overtests. The MOT damage line was developed from the long-pulse failure data and extrapolated into the short-pulse times. Consequently, the prediction is conservative in the short-pulse domain. A $T_D^{-\frac{1}{2}}$ line is fitted to the BDX reverse-biased failure data points. Second breakdown was visible in this data set.

The bulk surge impedance of the MOT transistor increased with pulse width. Eighteen impedance points in the 24- and 48-ns tests ranged from 3.889 to 21.294 ohms with a mean of 9.51 and a median of 9.6 ohms for the MOT transistors. In the microsecond regime, 19 data points ranged from 60 to 310 ohms with a mean of 188.39 ohms and a median of 197 ohms. The mean bulk surge impedance for the BDX transistors increased with pulse width from 69.17 ohms for 18 points at

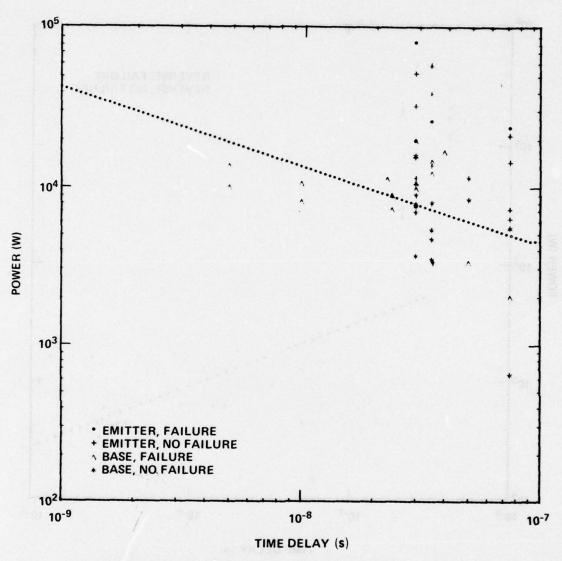
Figure 52. Damage line, power, Bendix 2N297A transistor.

30 and 35 ns to 87.3 ohms for 11 points at 75 ns. The bulk surge impedance for all data points ranged from 6.86 to 195 ohms with a mean of 73.2 ohms and a median of 57.3 ohms. The forward-biased impedance averaged 12 ohms.

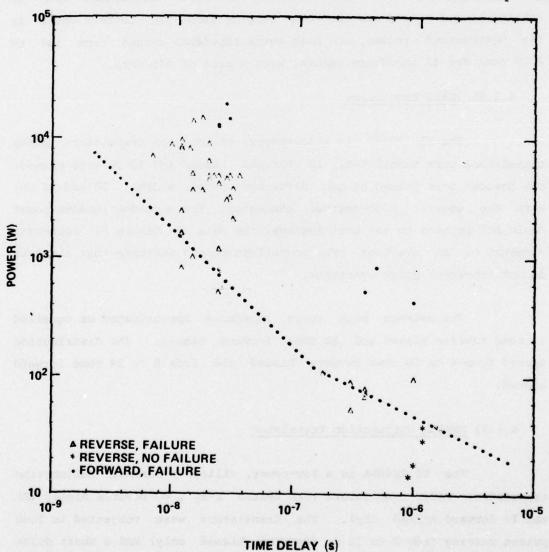
Figure 53. Damage curve, power, E-B, Crystalonics 2N328A transistor.

The data are plotted in figure 53. A thermal second-breakdown characteristic was apparent in the oscillograms; however, the transition into second breakdown was gradual, as seen in the short-pulse data. The voltage levels during the short-pulse tests ranged from ~700 to 800 V, while the breakdown voltage of the E-B junction ranged from ~40 to 100 V. Both of these characteristics of the data made difficult an accurate determination of the time delay. The

short-pulse data, therefore, must be viewed as slight overtests. The curve drawn in figure 53 represents an estimate based on the least squares fit of the long-pulse data and a conservative consideration of the short-pulse data.

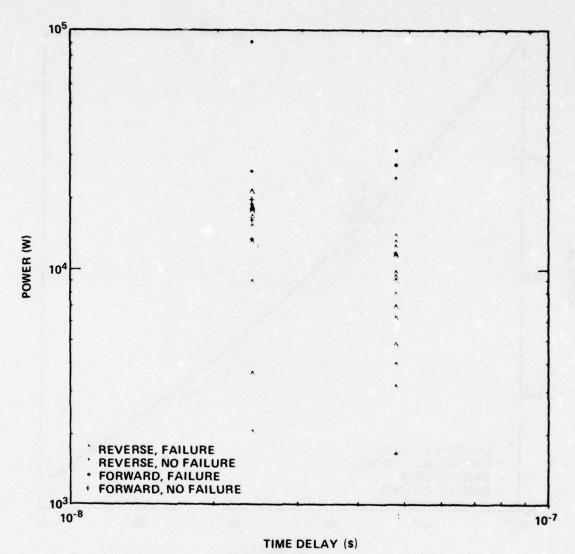
Figure 54. Damage points, power, E-B, Texas Instruments 2N335 transistor.

The TI 2N335 is a low-power, silicon npn transistor. Forty transistors were tested E-B, 10 forward biased and 30 reverse biased. The devices were pulsed at two different pulse widths, 50 and 24 ns, with the coaxial high-voltage generator. The second-breakdown point could not be seen on the oscillograms; the data of figure 54 represent somewhat of an overtest. The no-failure points indicate that the data do not represent gross overtests.

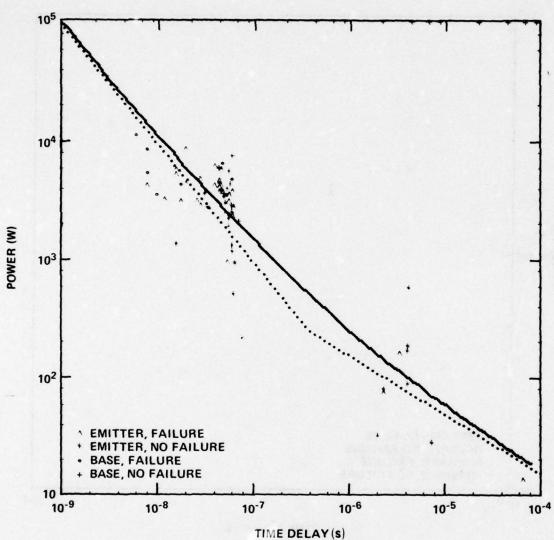
Figure 55. Damage curve, power, Texas Instruments 2N489A transistor.

The failures appeared to follow the thermal second-breakdown damage model throughout the entire model range, T_D^{-1} and $T_D^{-\frac{1}{2}}$. The point where the asymptotes of the T_D^{-1} and $T_D^{-\frac{1}{2}}$ curves intersect appears at a pulse width of 230 ns and peak power of 210 W (fig. 55).

The average bulk surge impedance was $\sim\!160~{\rm ohms}$ reverse biased and 190 ohms forward biased. The distribution spread from 59 to

430 ohms reverse biased and 100 to 300 ohms forward biased. The sample size forward biased was only 13 and may account for this value of resistance being ~12 percent larger than reverse-biased impedance.

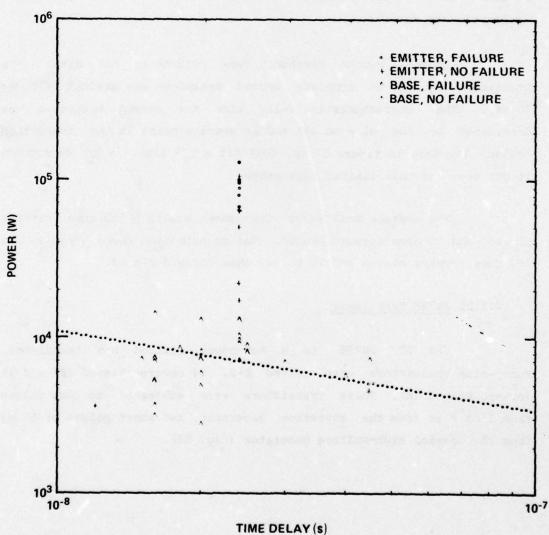
Figure 56. Damage line, power, Motorola 2N526 transistor.

The data exhibited a thermal second-breakdown response, though the transition region was gradual (in the tens of nanoseconds). An average value was chosen for the determination of the time delay. The data are fit to the $T_D^{-\frac{1}{2}}$ line (fig. 56) of equation (9) for reverse-biased tests. A T_D^{-1} dependence is not apparent for this limited test range.

The average bulk surge impedance was ~15 ohms reverse biased and 5.7 ohms forward biased. The distribution spread from 7 to 29 ohms reverse biased and 4 to 9 ohms forward biased.

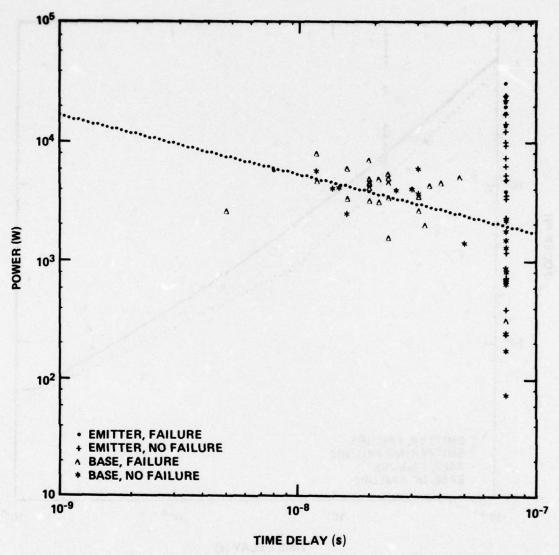
Figure 57. Damage line, power, General Instruments 2N598 transistor.

Thermal second breakdown was evident in the data. The transition region to complete second breakdown was gradual (10 to 20 ns). The characteristic delay time for second breakdown was determined by the pulse on set and an average point in the transition region. The data in figure 57 (p. 103) fit a $T_D^{-\frac{1}{2}}$ line. A T_D^{-1} dependency is not seen for this limited test range.

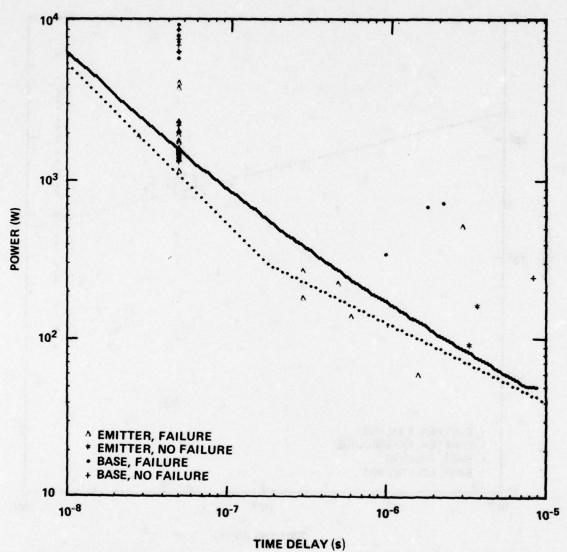
Figure 58. Damage curve, power, Texas Instruments 2N738 transistor.

The TI 2N738 is a low-power, silicon npn transistor. Forty-nine transistors were tested E-B, 34 reverse biased (E) and 15 forward biased (B). These transistors were subjected to long pulses from 1 to 8 μ s from the thyratron generator and short pulses of 50 ns from the coaxial high-voltage generator (fig. 58).

The average bulk surge impedance for the long pulses was ~18 ohms reverse biased and 1.0 ohm forward biased. The distribution spread from 9.0 to 49 ohms reverse biased and 0.7 to 1.4 ohms forward biased. For the short pulse, the corresponding impedances were 5.4 ohms reverse biased and 3.6 ohms forward biased.

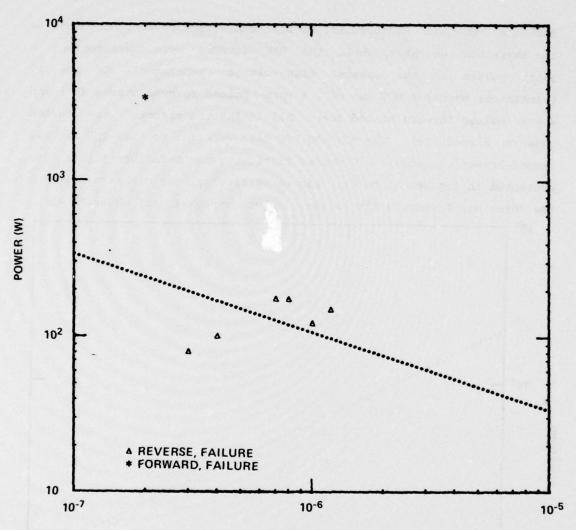
TIME DELAY(s)
Figure 60. Damage line, power, E-B, Fairchild 2N1132A transistor.

Both the MOT and FSC transistors were characterized to long pulses on the thyratron generator, while the RAY devices were characterized to short pulses on the coaxial high-voltage generator. Of the 10 transistors each for MOT and FSC, 6 were pulsed reverse biased (B+) and 4 were pulsed forward biased (E+). All 24 RAY transistors were tested reverse biased (B+). The MOT and FSC data were fit to the $T_D^{-\frac{1}{2}}$ thermal second-breakdown model. Computer-fitted curves to failure points are presented in figures 59 to 61. Figure 62 displays the combined data for the three manufacturers fit to the complete expression of equation (9).

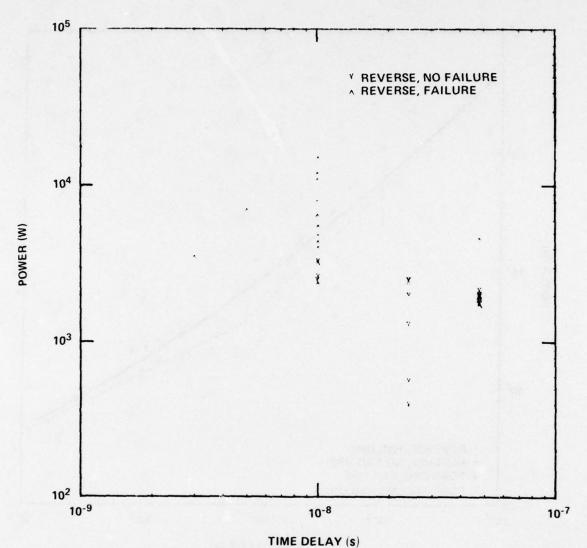
Figure 61. Damage points, power, E-B, Raytheon 2N1132A transistor.

All long-pulse test data indicate a thermal second-breakdown damage effect. Many points (fig. 61) reflect an overtest condition. The second-breakdown point was difficult to distinguish. The MOT transistor seems to be the least sensitive to high-level pulses and RAY, the most sensitive.

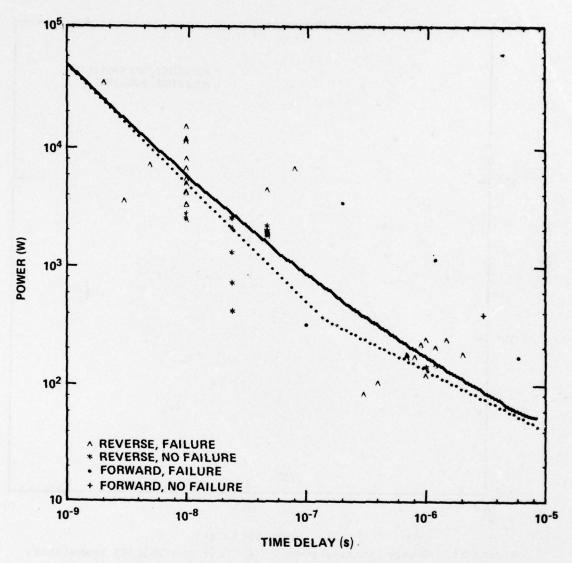
Figure 62. Damage curve, power, E-B, combined data for Motorola, Fairchild, and Raytheon 2N1132A transistors.

increasing pulse width. This decrease was interesting because impedance has been observed to increase with increasing pulse width near the failure point. The reverse-biased impedance of the combined sample for the various pulse widths was 2.7 ohms for the long pulses, 9.0 ohms for 48 ns, 21 ohms for the 24-ns open-circuit pulses, and 28 ohms for 10 ns. The sample sizes were small, but the spreads were all within a factor of two. The average impedance for the forward-biased transistors for the

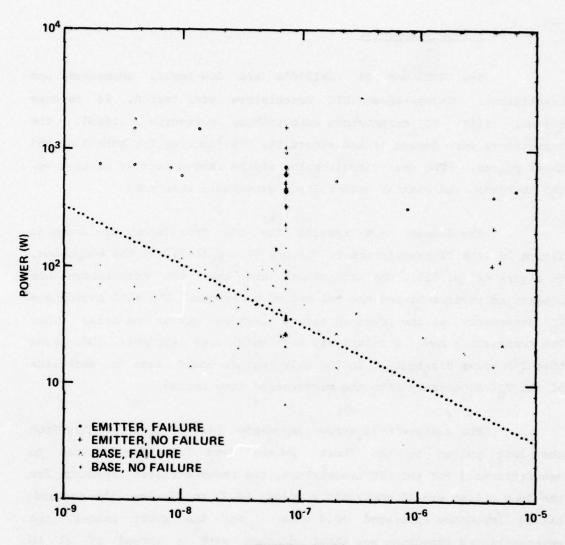
TIME DELAY(s)
Figure 65. Damage line, power, Motorola 2N1204 transistor.

There appears to be a fair correlation between the failure data and the thermal second-breakdown model. A T_D^{-1} curve is fitted to the data (fig. 65). No T_D^{-1} dependency is seen for the shorter pulses. The forward failure data appear to follow the reverse-biased failure data, but at a higher (~1 decade) power level.

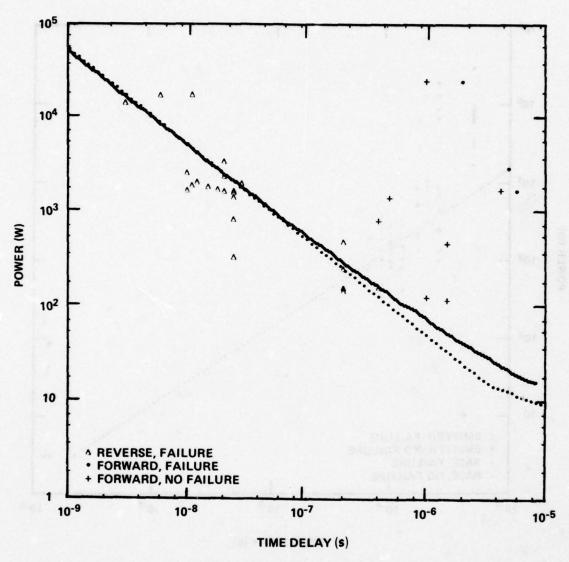
Figure 66. Damage curve, power, E-B, General Instruments 2N1308 transistor.

The damage test results for GIC transistors are shown in figure 66; the TI transistors in figure 67 (p. 114); and the composite, in figure 68 (p. 115). The indications are that the transistors are subject to reverse-biased thermal second breakdown. The data indicate a $\mathbf{T}_{\mathbf{D}}^{-1}$ dependency of the power to second breakdown versus the delay time. The transistors have a relatively high bulk surge impedance, indicating that $\mathbf{I}^2\mathbf{R}$ power dissipation in the bulk regions could cause the extension of the $\mathbf{T}_{\mathbf{D}}^{-1}$ dependency into the microsecond time regime.

The average bulk surge impedance varied significantly from the long pulses to the short pulses and from manufacturer to manufacturer. For the GIC transistors, the reverse-biased impedance for the long pulses was 46 ohms with a spread of 22 to 92 ohms; the forward-biased impedance averaged 10.5 ohms. For the short pulses, the reverse-biased impedance was about 62 ohms with a spread of 31 to 89 ohms. For the TI transistors, the reverse-biased impedance for long pulses was ~551 ohms with a spread of 160 to 1200 ohms. For the short pulses, the reverse-biased impedance was ~68 ohms within a spread of 19 to 145 ohms; and the forward-biased impedance averaged 35 ohms with a spread of 14 to 65 ohms.

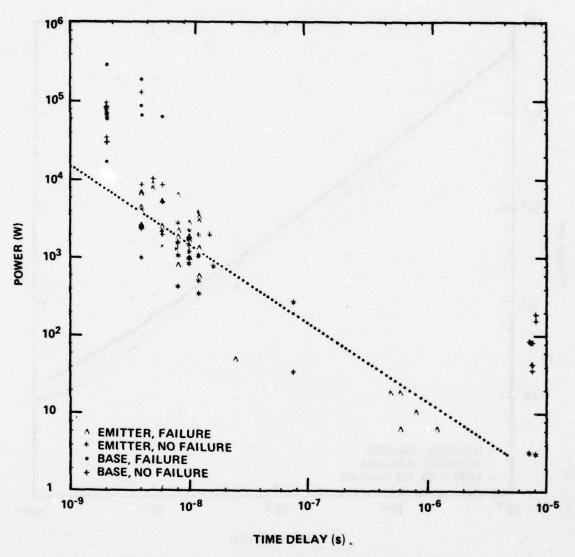
Figure 67. Damage line, power, E-B, Texas Instruments 2N1308 transistor.

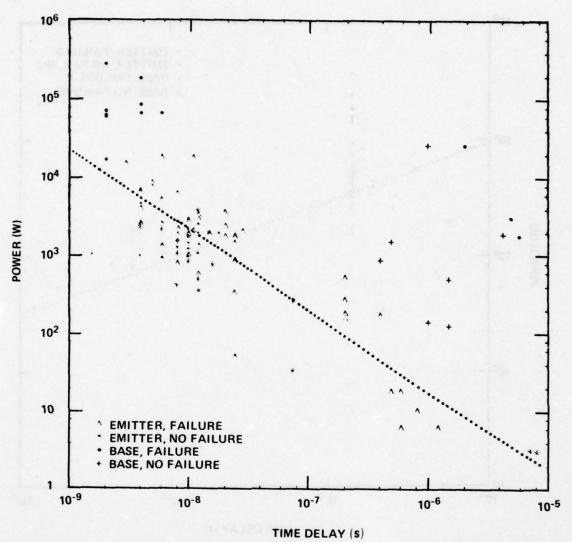
Figure 68. Damage line, power, E-B, combined data for General Instruments and Texas Instruments 2N1308 transistors.

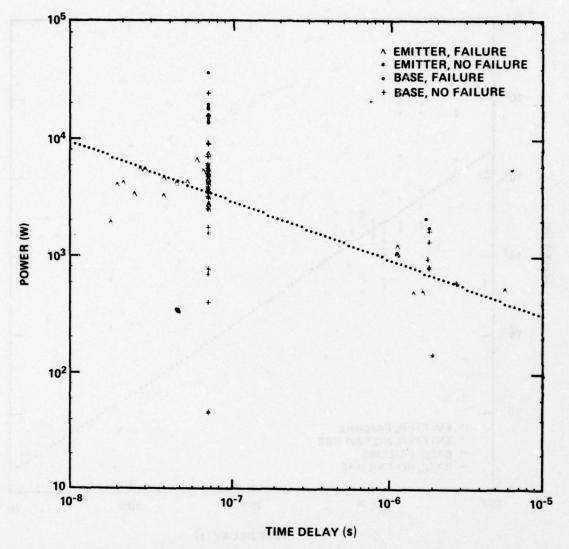
The damage data indicate a reverse thermal second-breakdown failure mechanism. The data points are plotted in figure 69. They are fitted to the $T_D^{-\frac{1}{2}}$ model.

Figure 69. Damage line, power, Motorola 2N1613 transistor.

The average bulk surge impedance for the long pulses equalled ~1.4 ohms reverse biased and ~0.10 ohms forward biased. The distribution spread from 0.5 to 2 ohms reverse biased and 0.04 to 0.17 ohm forward biased. For the short pulses, the corresponding impedances equalled ~3.7 ohms reverse biased and ~3.0 ohms forward biased.

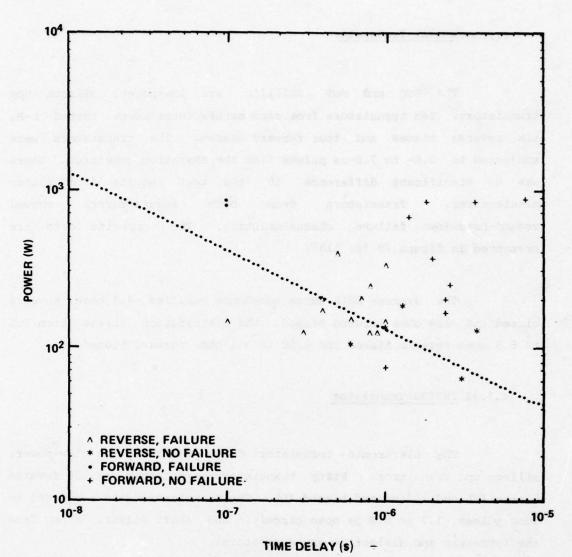
The FSC and MOT 2N1711's are low-power, silicon npn transistors. Ten transistors from each manufacturer were tested E-B, six reverse biased and four forward biased. The transistors were subjected to 0.6- to 7.8- μs pulses from the thyratron generator. There was no significant difference in the test results from either manufacturer. Transistors from both manufacturers showed second-breakdown failure characteristics. The composite data are presented in figure 70 (p. 118).

Figure 70. Damage line, power, combined data for Fairchild and Motorola 2N1711 transistors.

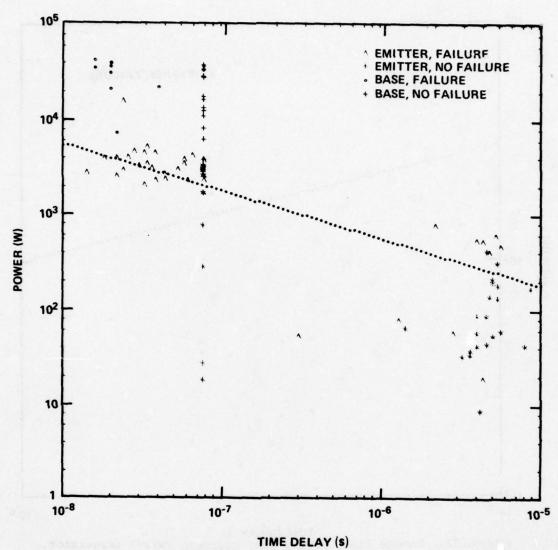
The data indicate that reverse-biased failure was due to thermal second breakdown. A $T_D^{-\frac{1}{2}}$ line has been fitted to the reverse-biased failure data (fig. 71, p. 118).

The average bulk surge impedance equalled ~5.0 ohms reverse biased and ~2.9 ohms forward biased. The distribution spread from 1.1 to 45 ohms reverse biased and 1.8 to 4.5 ohms forward biased.

Figure 71. Damage line, power, Electronic Transistors 2N2198 transistor. relatively high bandwidth, and high current capabilities. Eight RAY and eight FSC transistors were tested E-B. All were subjected to long pulses, 1- to 6-µs open-circuit widths, on the thyratron generator. All were pulsed reverse biased.
